Manhole Inspection Summary

Manhole # S23GG1022MH

Location Address: **4139 BUENA VISTA AVE**

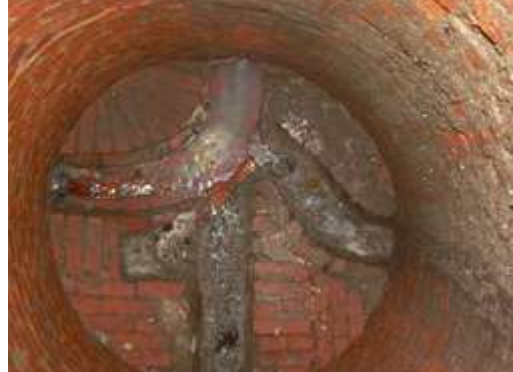
Top View

☐ Parged ☒ **Debris** (not Condition related)

Condition: ☐ Sound ☐ Cracked ☐ Root Intrusion ☒ **Deteriorated** ☐ Leaks ☒ **Debris**

Surcharge ☒ **Evidence Of Surcharge** Depth: **1** (ft.) ☐ Active Surcharge Present

Evidence of surcharge - Bench debris.
Channel debris.

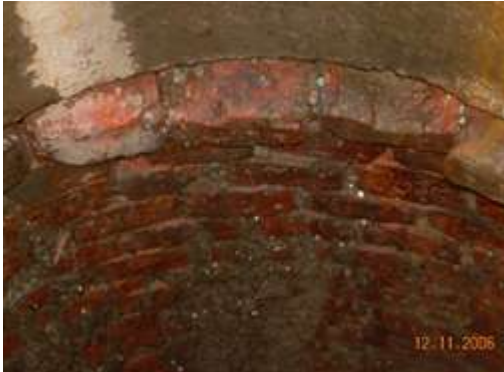
Defect

Frame Offset: **2** (in.)

☒ **Leaks**

Condition: ☐ Sound ☐ Cracked ☐ Root Intrusion ☐ Loose Brick ☒ **Deteriorated**

Infiltration: ☐ None ☒ **Joint** ☐ Cracks ☒ **Mortar** ☐ Roots ☐ Wall

Frame leaks. Frame offset. Adjustment
deterioration and infiltration.

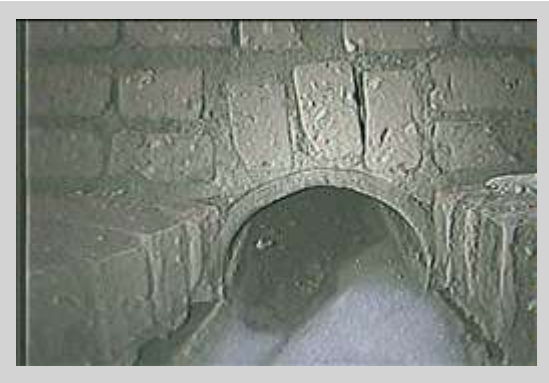
8 in. Circular Gravity Sewer Pipe Out @ 12 O'Clock

Channel deterioration.

Deposits: ☐ None ☒ **Mud** ☐ Sludge ☒ **Debris** ☐ Grease

Infiltration: **Evidence** Pipe Seal Cond: **Unknown**

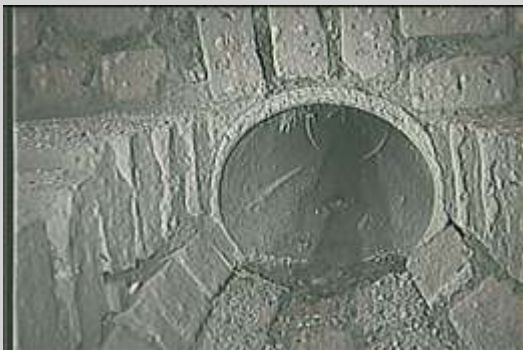
Channel deterioration.
